STATE OF WASHINGTON DEPARTMENT OF NATURAL RESOURCES
WILDLAND FIRE INVESTIGATION REPORT

Case File Number
 20-V- AKV
 Other Related No.
 WA--NES--2151

Incident Name: Babb	WildCAD Incident No. 2151	Incident Date: 09/07/2020
Program Index: <input checked="" type="checkbox"/> 221 <input type="checkbox"/> 222	Project Code: AKV	Region Fire No. 522
Acres Burned: 15,266		Reporting Office: Northeast
Investigation Report By: G. Margheim		Case Ref. No.
Other Agents/Officers: Eugene DuPrey INVf(t), John McDonald INVf, Terry Liebrecht INVf

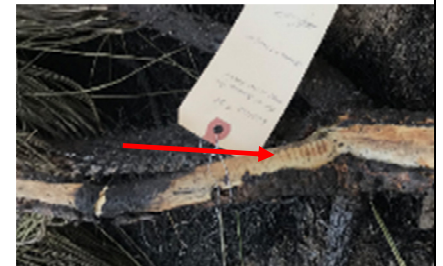
Upon further inspection of the top portion of the branch, we observed marks or striations perpendicular on the branch that did not appear to be natural. These marks appeared to similar in size to the conductors we obtained by the Avista Utility crew. The photo to the right shows the striations on the branch. Photo log #18 (IMG0073) cropped and rotated.

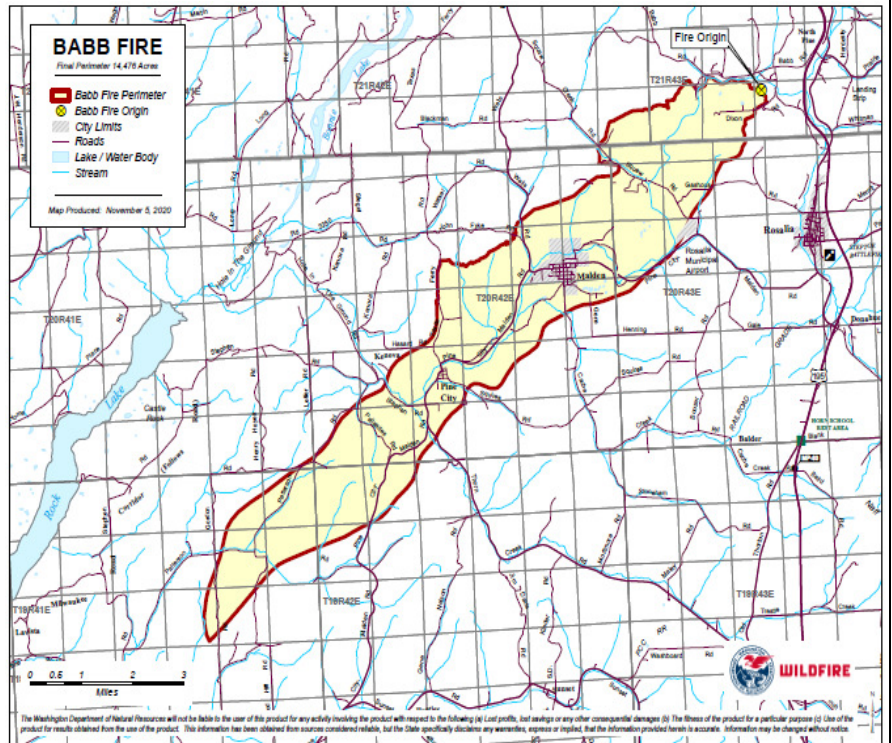
The weather for September 7, 2020 recorded at the Turnbull remote automated weather station showed the winds begin to pick up around 8 A.M. with average wind speed of 8 MPH with gusts to 21 MPH. Near the time of fire start, the average wind speed was 18 MPH with gusts to 34 MPH out of the north northeast with an relative humidity of 29 percent and fuel temperature of 72 degrees. Historically the winds in this area are out of the southwest this time of year. The picture to the right depicts the Babb fire as a wind driven fire based on the long narrow fire perimeter. The towns of Malden and Pine City were southwest of the origin for this fire.
